# Manhole Inspection Summary

Manhole # S33YY1010MH

**Location** Address: **SAINT DUNSTANS RD** Cross Street: **PURLINGTON WAY**

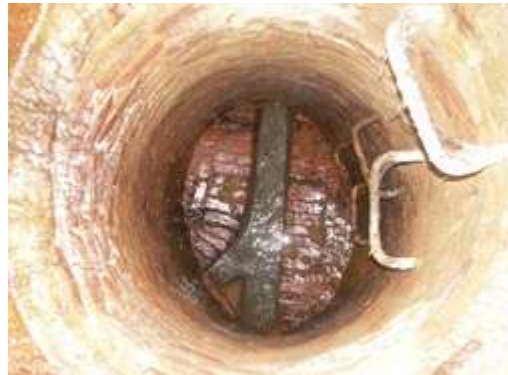
Top View

Corroded steps. Evidence of surcharge - Bench debris.

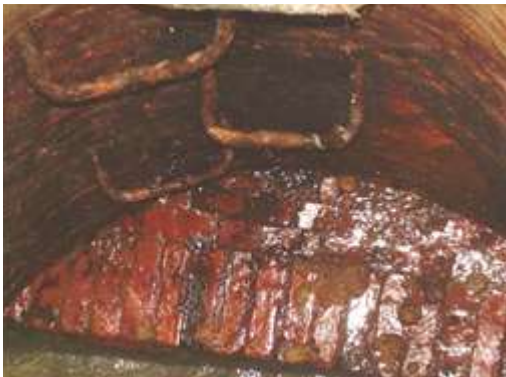
Evidence of surcharge

**Surcharge** ☒ **Evidence Of Surcharge** Depth: **5** (ft.) ☐ Active Surcharge Present

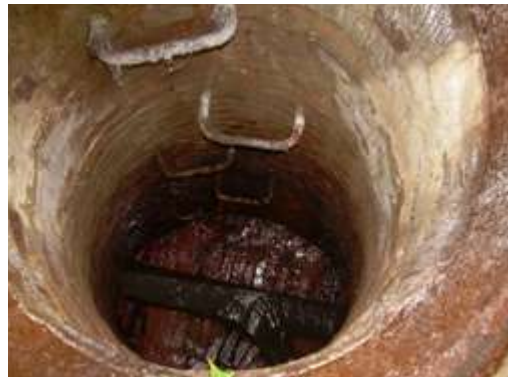
Defect

Frame leaks. Adjustment deterioration and infiltration. Corbel and Barrel infiltration - other side.

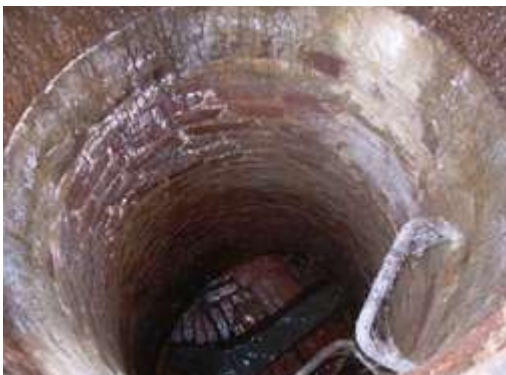
Defect

Frame leaks. Adjustment deterioration and infiltration. Corbel and Barrel infiltration.

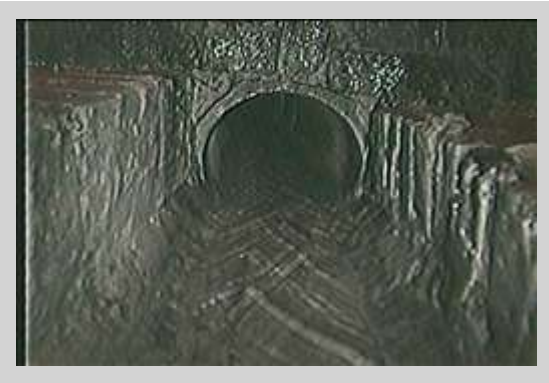
### 8 in. Circular Gravity Sewer Pipe Out @ 12 O'Clock

Comments **The invert measurments may not be accurate due to the slanted elevation of the ground. The O12 pipe seal is not flush to the pipe.**

Infiltration: **Evidence** Pipe Seal Cond: **Unknown**

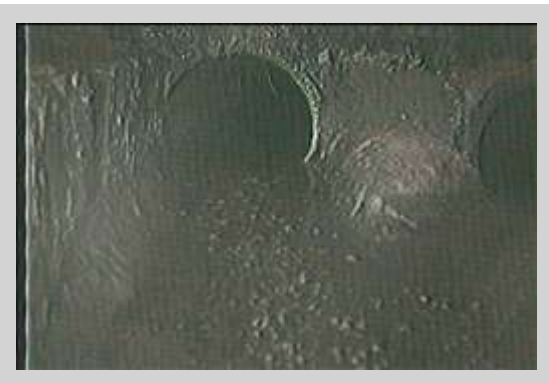
### 8 in. Circular Gravity Sewer Pipe In @ 6 O'Clock

Deposits: ☐ None ☒ **Mud** ☐ Sludge ☒ **Debris** ☐ Grease

Silt Depth: **0.5** (in.) Deposits Extent: **Light**

Infiltration: **Evidence** Pipe Seal Cond: **Unknown**

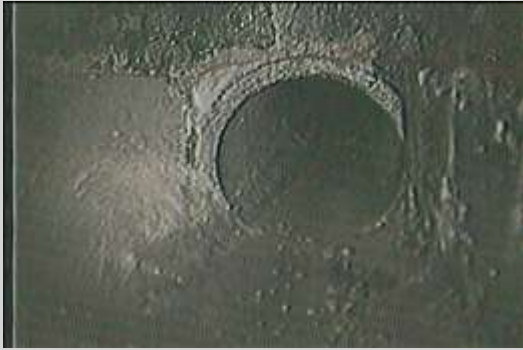
Pipe In @ 7 O'Clock

Infiltration: **Evidence**
